# Bathhouse Row Adaptive Use Program

The Bathhouse Row Landscape: Technical Report

HOT SPRINGS NATIONAL PARK  
Garland County, Arkansas

June 1985

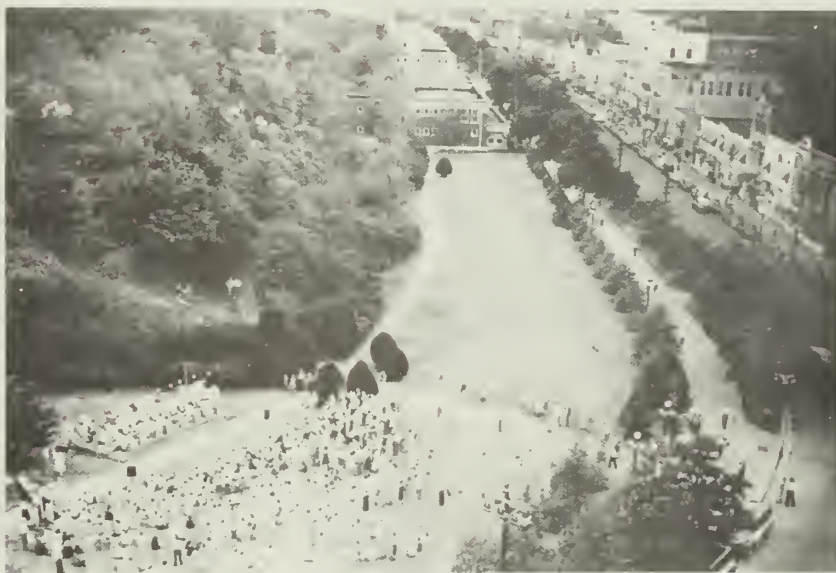
Figure 3. Arlington Lawn, 1943  
(Source: Hot Springs National Park)

Major landscape changes along Bathhouse Row were triggered when the Arlington Hotel burned in 1923. Numerous suggestions and site plans were presented by various groups for the now vacant area, noting its convenient location near the central business district and presuming an intense recreational use for the area. At the insistence of NPS Assistant Director Cammerer, however, the area was kept as an open, grassy expanse. Magnolias were planted along the new sidewalk, aligned with the promenade in front of the bathhouses. White gravel walkways were laid out across the open lawn, and trees and flowering shrubs were planted along the inside of the walk. In 1931, a law was passed to preserve the area for park and landscaping purposes and to forbid its leasing for bathhouses or other structures. The lawn soon began to be used by various local groups for assemblies, pageants, holiday programs, and special ceremonies--a use that continues today.

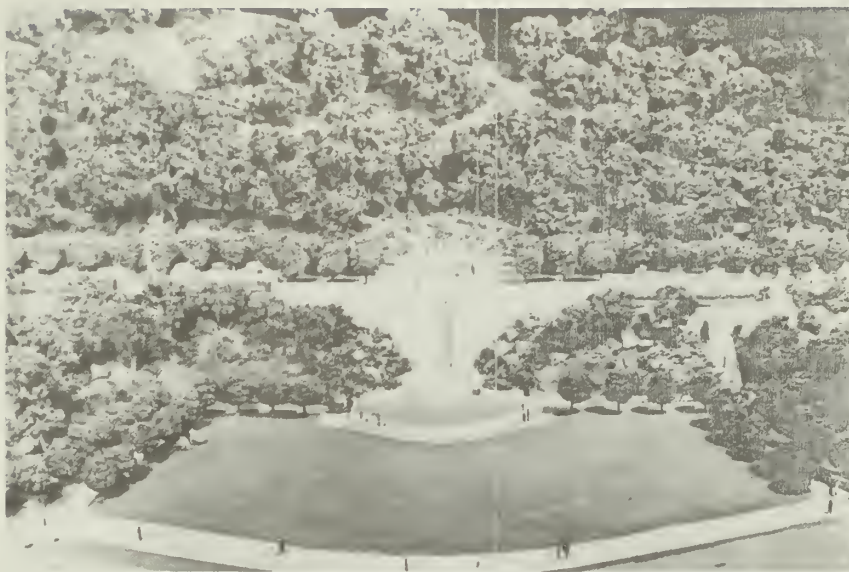
Figure 4. Model of Cascade on the Grand Promenade, Arlington Lawn, ca. 1938  
(Source: Hot Springs National Park)

Early in the 1930s, a comprehensive general development plan was done for the entire park. The plan proposed formal development of the west slope of Hot Springs Mountain, including a hot water cascade and a new

promenade with large entrances on either end. The greenhouse, the old superintendent's house, and ancillary structures on the northern end of the row were to be removed. The private property across Central Avenue west of Bathhouse Row was to be purchased and returned to natural conditions more appropriate to a national park. Park boundaries would be expanded to include the balance of the upper slopes of North, West, and Sugarloaf Mountains to give Hot Springs the space, character, and atmosphere of a "real national park." Due to the Depression, however, there were no funds available for land acquisition, so this part of the plan was postponed indefinitely.

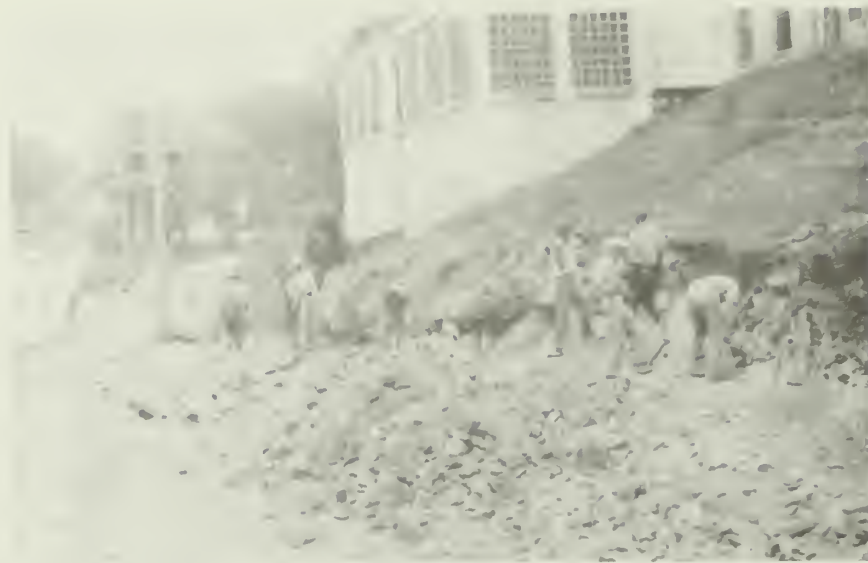
Figure 5. Grand Promenade Cut near Army and Navy Hospital, early 1930's  
(Source: Hot Springs National Park)

Construction of the Grand Promenade was begun in the early 1930s, but despite repeated requests from the superintendent, funding for the promenade was omitted from the 1935 and 1936 programs. Although the alignment grading was virtually completed, the project was stopped. The Grand Promenade project had been hindered throughout the 1930s by numerous design changes and delays occasioned by a variety of engineering problems. It is also likely that the reorganization of the Service, the popular view of national parks as "natural" entities, and escalating costs heavily influenced the Director's decision to abort the project at this point.

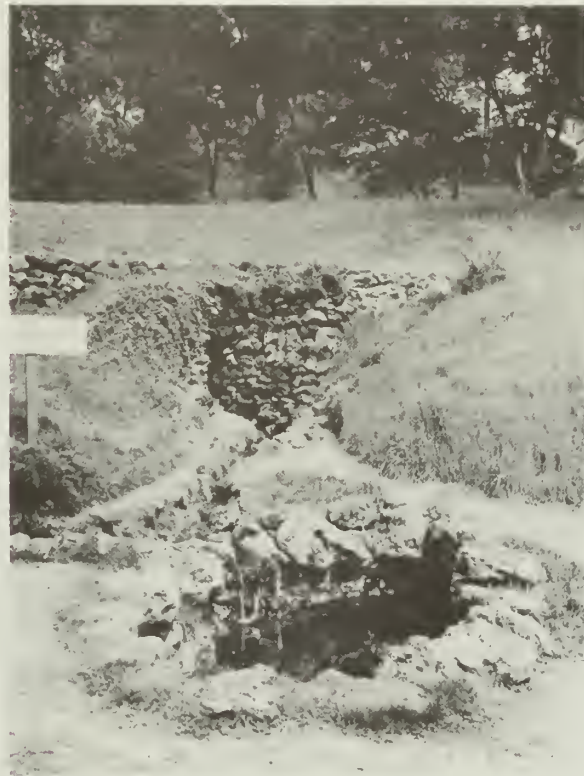
Figure 6. Display Spring behind the Maurice Bathhouse, date unknown  
(Source: Hot Springs National Park)

"natural" spring in action. After several months of debate and many different proposals, the idea of a formal fountain was dropped and designs were completed for a display pool between the Maurice and Fordyce Bathhouses. Two seeps were led together to run over small

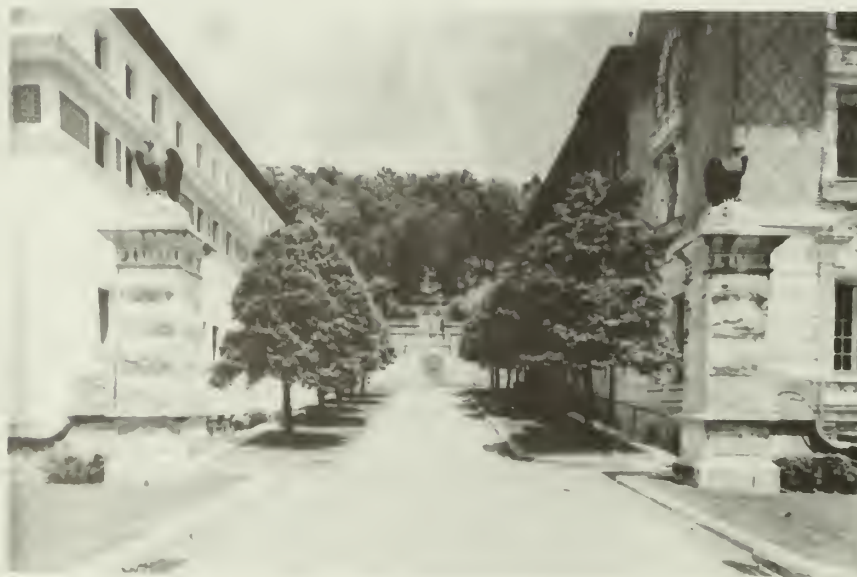
Figure 7. Main Entrance, 1984  
(Source: Historic American Buildings Survey)

In 1951 an elevated area of ground once used as a band platform was removed from the Arlington Lawn and the area was graded, seeded, and sodded. The nearby stone steps and retaining wall were renovated, and vegetation was cut to allow better visibility. In 1958 the main entrance was further altered by removal of the concrete oval quadrants, the base of the old exedras. These were replaced with low plantings and ground cover. The drive was reworked to change it to a pedestrian walkway and to prevent use by vehicles.

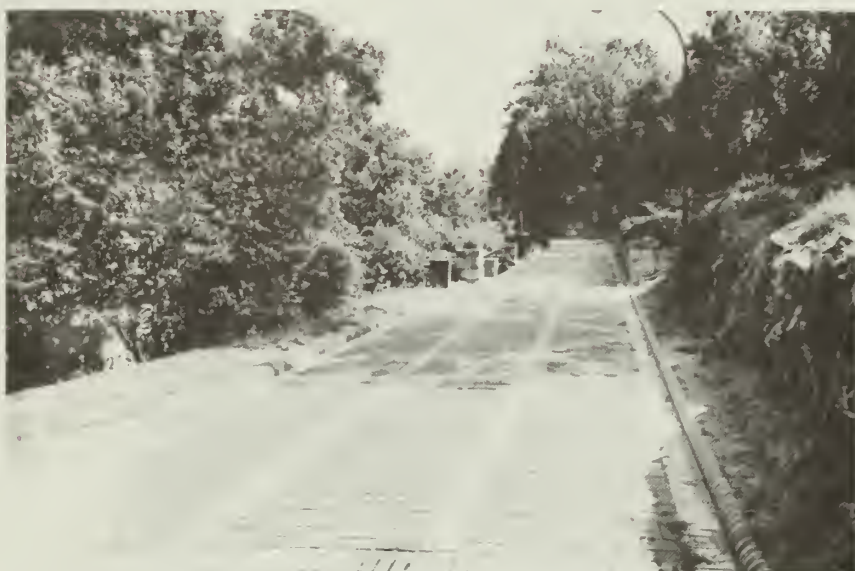
Figure 8. Grand Promenade, Looking North, 1984  
(Source: Historic American Buildings Survey)

During the 1950s, the promenade proposals were revived, additional changes were made in the plans, and the project was finally completed in 1959. For the most part, a simplified version of the 1930s and 1940s plans and alignments was used. The elaborate cascade was omitted, the walkway width was reduced, the terrace just north of the Fordyce was graded back, and the new promenade structures were integrated into the Stevens Balustrade and the old main entranceway. The superintendent's residence was razed and the area was graded prior to the final work on the north end of the promenade. A modest, naturalistic cascade of hot water was added near the north end of the promenade late in the period, long after promenade completion. Although various proposals were made to improve the rear view of the bathhouses as seen from the new Grand Promenade, these plans were never implemented. Instead, over the years the vegetation along the Promenade was allowed to grow, closing off the view in all but a few areas.

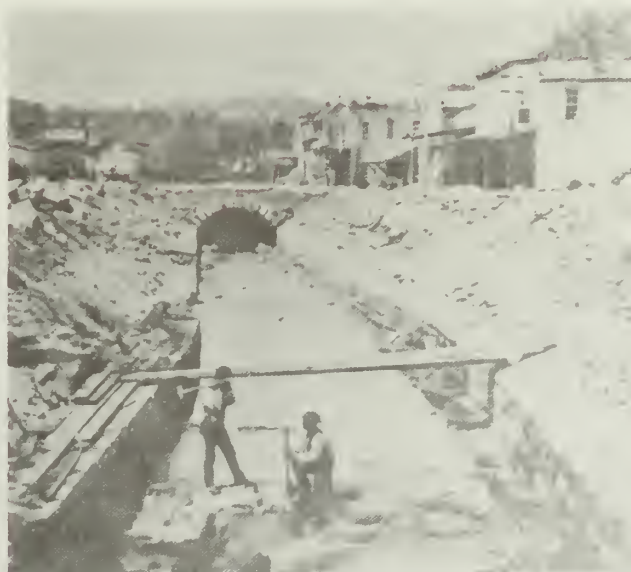
Figure 9. Construction of the Hot Springs Creek Arch, 1883-84  
(Source: Garland County Historical Society; cited by Brown, 1982, p. 36)

There were three periods of site planning that contributed significantly to landscape development of Bathhouse Row and its environs. The first, dating from around 1877 to 1884, occurred when the Hot Springs Commission laid out the town and defined areas where development should occur. Shortly thereafter, Hot Springs Creek was arched over and the narrow, circumscribed valley floor was leveled, creating a unified linear landscape space in front of, and including, the row of Victorian style bathhouses.

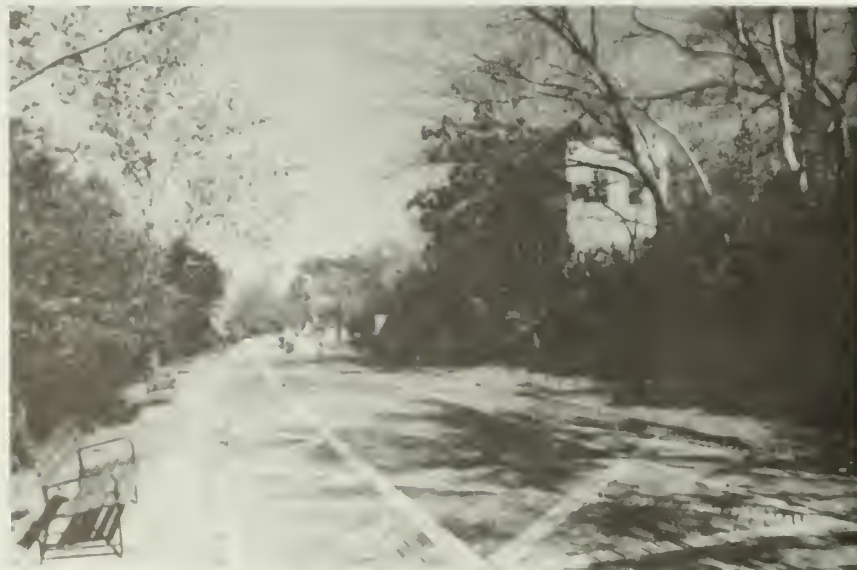
Figure 11. Grand Promenade, Looking North, 1984  
(Source: Hot Springs National Park)

The third, and final, phase of development that significantly defined landscape spaces began during the 1930s. Design and construction was confined to the upper terrace and involved creation of a brick-paved Grand Promenade with sitting areas, fountains, vista points, and three major architectural entrances.

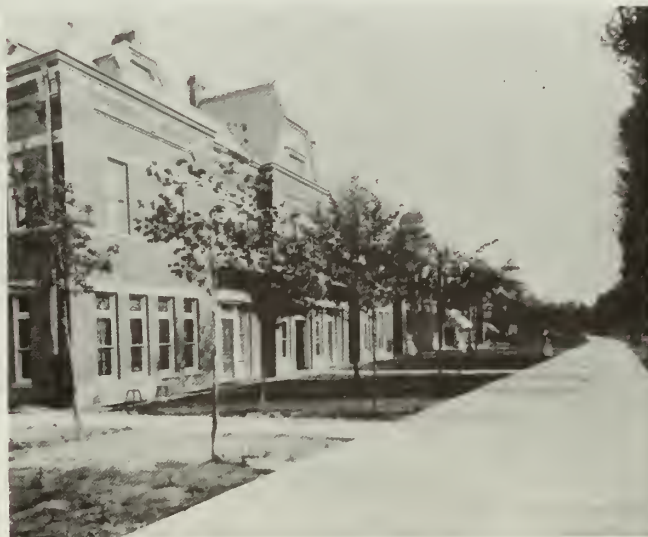
Figure 12. Bathhouse Row, ca. 1894-95 (Note double row of trees along inside of Promenade--Source: Mitchell, Scenes in Arkansas, 1896)

Turn-of-the-century gardens were highly structured architectural spaces. One of the strengths of this period, the long axial element which tied garden spaces together, was borrowed from the French style. Stevens formalized the Magnolia Promenade in this style as a tree-lined pedestrian axis along the entire length of Bathhouse Row. The promenade was

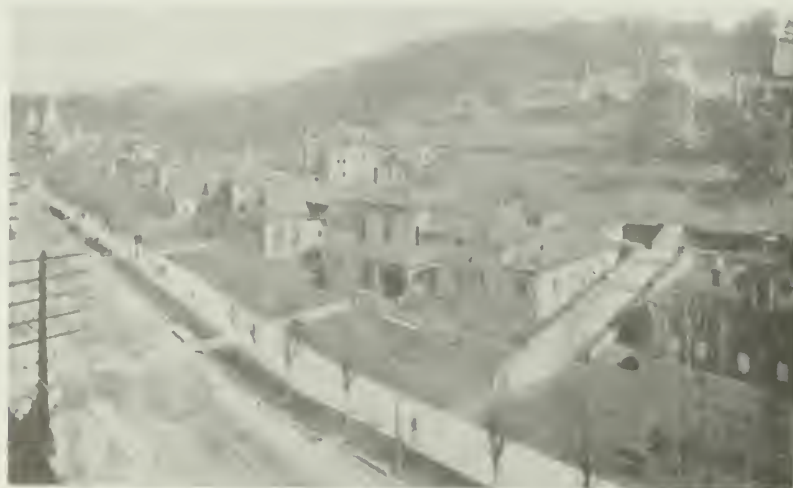
Figure 13. Bathhouse Row, with South Park beyond, ca. 1896 (South Park is pictured directly behind bathhouses and stone stairs--Cutter's Guide, 1896)

The South Park, later known as Reserve Park, extended from the Government Free Bathhouse south to Reserve Avenue. Bordered by the bathhouse supply road and the Army and Navy Hospital grounds, this park was accessed by stone stairs and landings which extended up the hillside between the Ozark and Rammelsburg bathhouses. Here the "natural plantings"--chiefly shrubbery and lawns--provided an open green expanse in contrast to the large Army and Navy Hospital structures above.

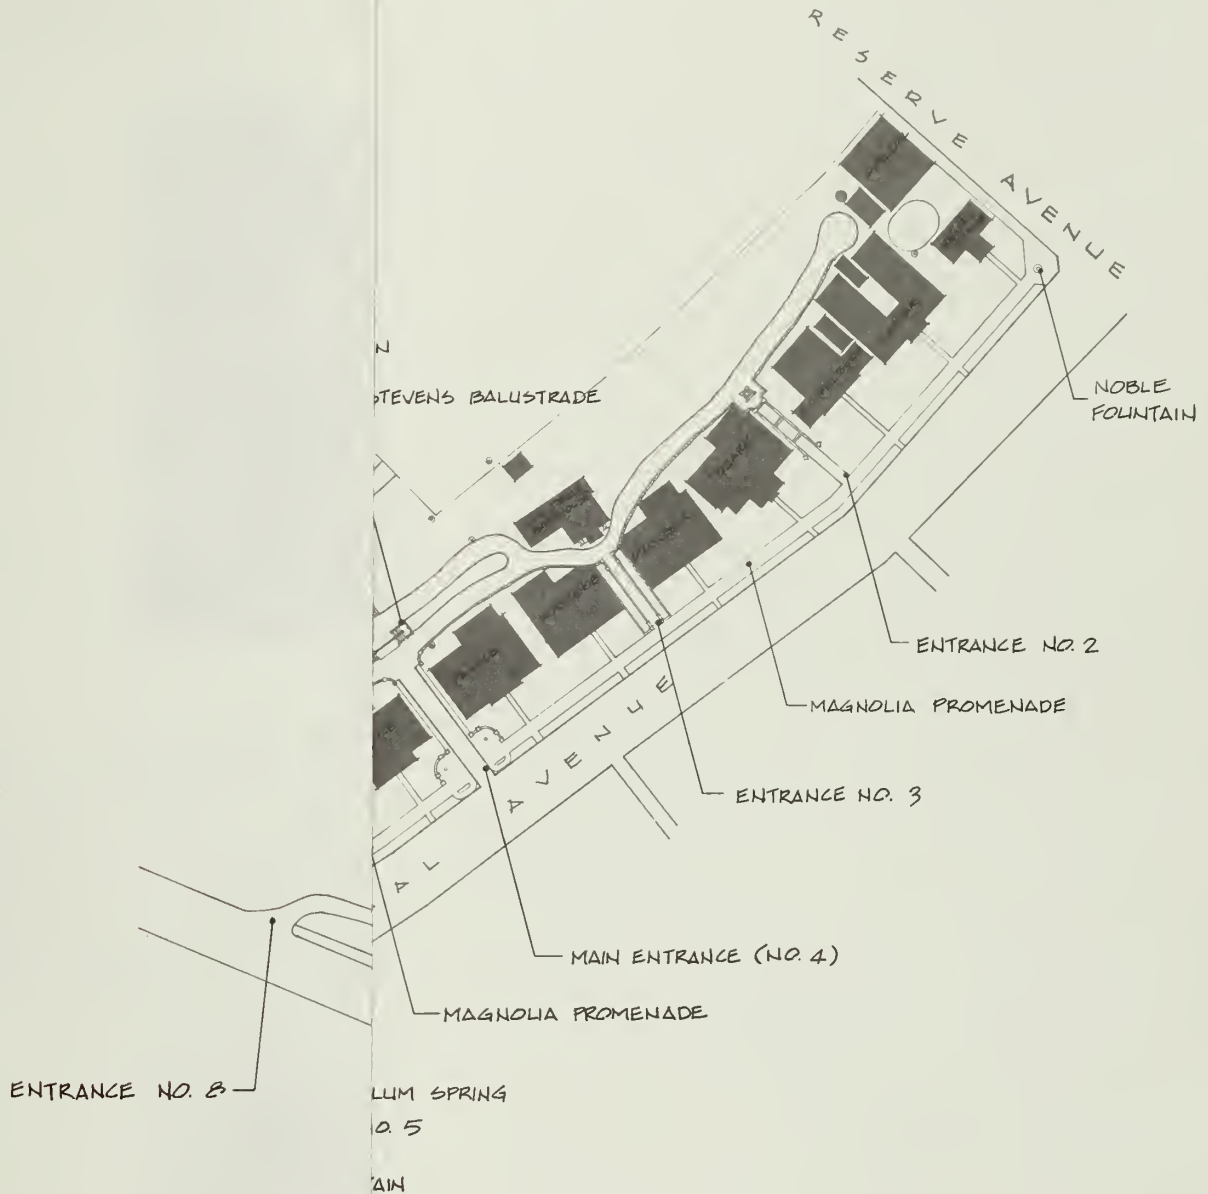
PREPARED <i>G. Johnson</i> DESIGNED <i>G. Johnson</i> DRAWN CHECKED <u>6/85</u> DATE	TITLE OF DRAWING <b>SITE PLAN</b> <b>BATHHOUSE ROW LANDSCAPE</b> <b>1890's</b>	DRAWING NO <u>128</u> <u>25,002A</u> PKG NO. SHEET OF
---	---	--

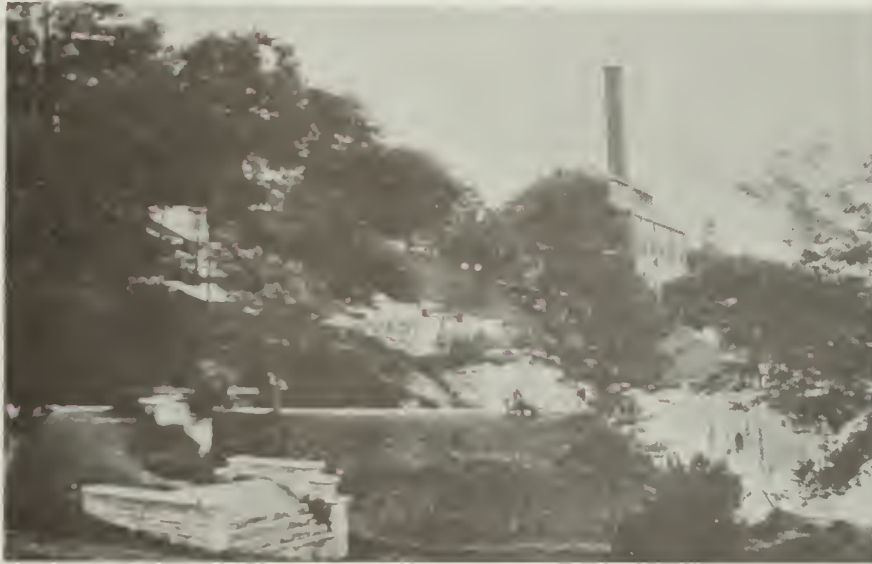
Figure 14. Foreground Park, ca. 1914  
(Source: Hot Springs National Park)

The Foreground Park lay just above and beyond the main entrance. It was bounded by stone retaining walls on the downhill side, and uphill by the main drive and woods. The center of this park was a terraced, tree-shaded area with massed plantings which formed a circular intermediate landing for the main entrance stairway; above was the bandstand pavilion.

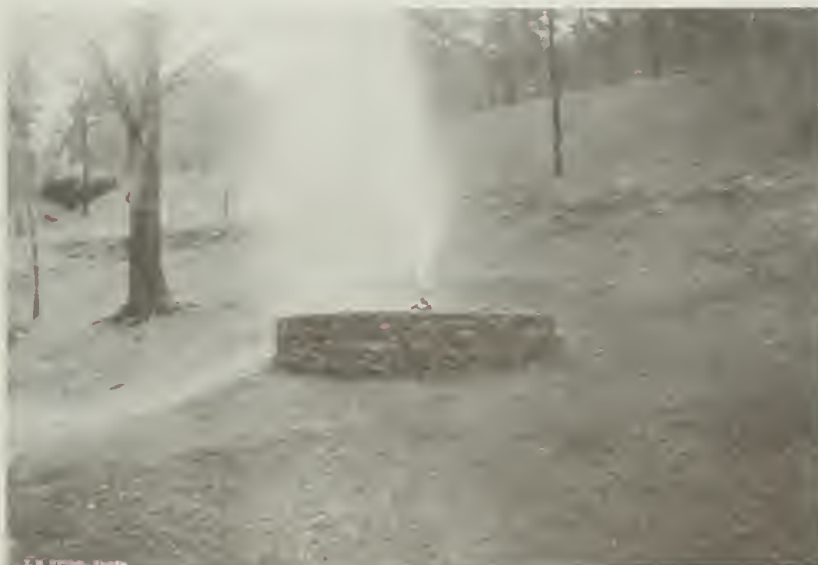
Figure 15a. Tufa Fountain located in the Tufa Park, ca. 1913-1914  
(Source: Hot Springs National Park)

Just to the north of the Foreground Park was the Tufa Park which continued around the mountainside to a point adjacent to and behind the Arlington Hotel. In this park the natural features of the tufa were left exposed, and plantings of vines and shrubbery were kept to a minimum. Although the clusters of wooden cooling tanks were still visible behind the various bathhouses, the unsightly system of above-ground wooden troughs and piping had been removed, the springs had been arched over with white rustic stone, and grass had been planted to complete the improvement of this area.

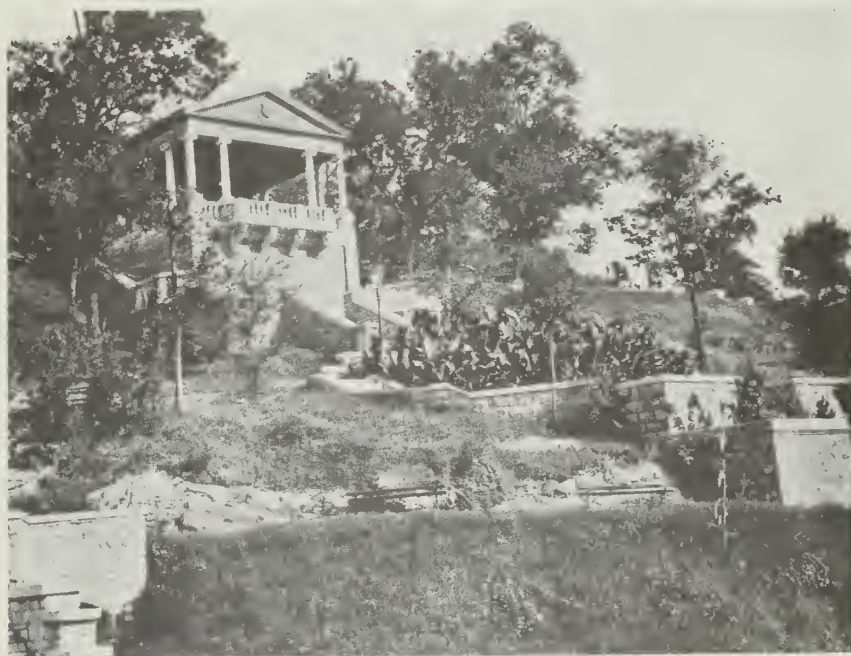
Figure 17. Foreground Park, Bandstand, before 1914  
(Source: Hot Springs National Park)

The Foreground Park and the main, or Central Avenue, entrance leading between the Independent and Palace bathhouses formed the core of the Reservation's formal landscape. Formal structure in the Italian style found its expression in the Bathhouse Row landscape in the architectural treatment of this space. Italian landscape designs typically used architectural elements--balustrades, balconies, paved terraces, and stairways--to structure space and traverse topographic obstacles. Stevens used elements of the Italian style to physically provide access to the upper terrace and to construct an architectural axis that provided a strong line of sight from Central Avenue to the pavilion located on the upper terrace. Tall stone columns topped by bronze eagles, joined by curved panel walls and abutting exedras with fountains, provided a strong architectural definition of space at the Reservation's main entrance. At the rear, the entrance drive and sidewalks led to a white stone balustrade and shell fountain, plantings, stairs, and a bandstand pavilion set among the trees in the foreground area. Retaining walls stretched along the rear of the bathhouses. In keeping with the scale of the adjacent bathhouses, the main entrance provided a natural entranceway to the reservation and to the mountain above while allowing service to the rear of the bathhouses. The stone stairs, balcony, balustrade, and plantings formed a formal composition of architectural elements leading to the pavilion--a small but elegant structure intended to provide a resting spot--and a platform for viewing the city below.

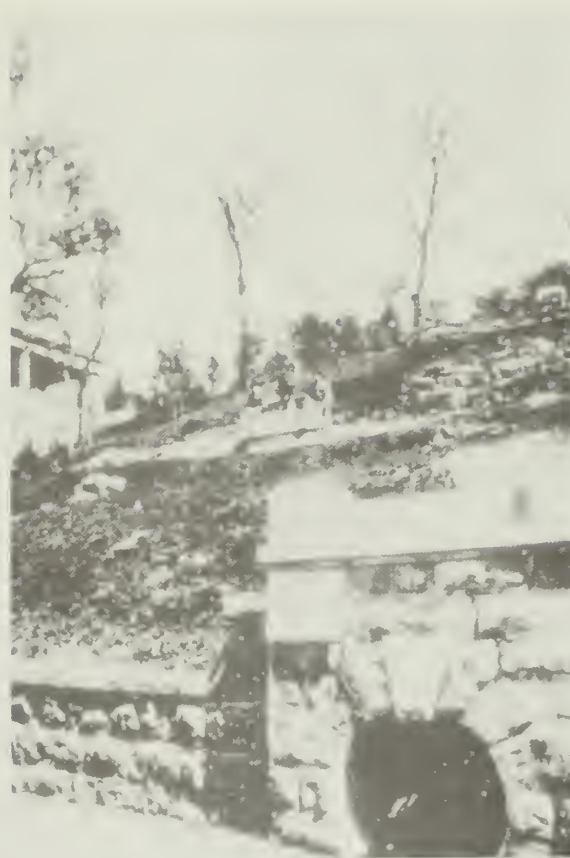
Figure 20. Stevens Spring, date unknown  
(Source: Hot Springs National Park)

period, mostly sculptured from stone not cast iron. During the 1890s, "display" springs were formalized and structured. Several springs--among them Dripping Spring, Hale Spring, and Stevens Spring--were arched over with white limestone facades and used to provide hot water for drinking. Attractive stone and wood pavilions, since removed, sheltered Alum Spring along the promenade and Cold Spring at the Fountain Street entrance. Most of the remaining springs were covered over and diverted to bathhouse use.

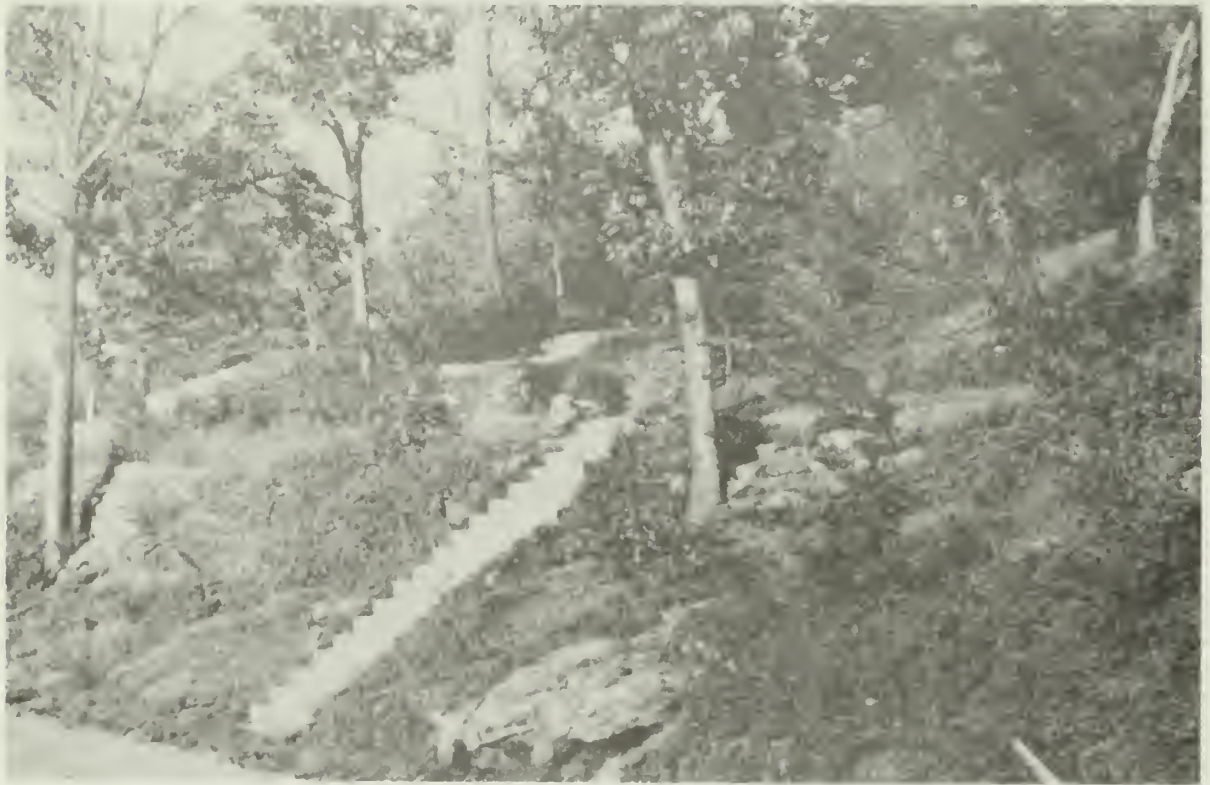
Figure 22. Upper Terrace on Hot Springs Mountain, Looking Northeast at Informal Plantings, 1898  
(Source: U.S.D.O.I., Report of the Superintendent)

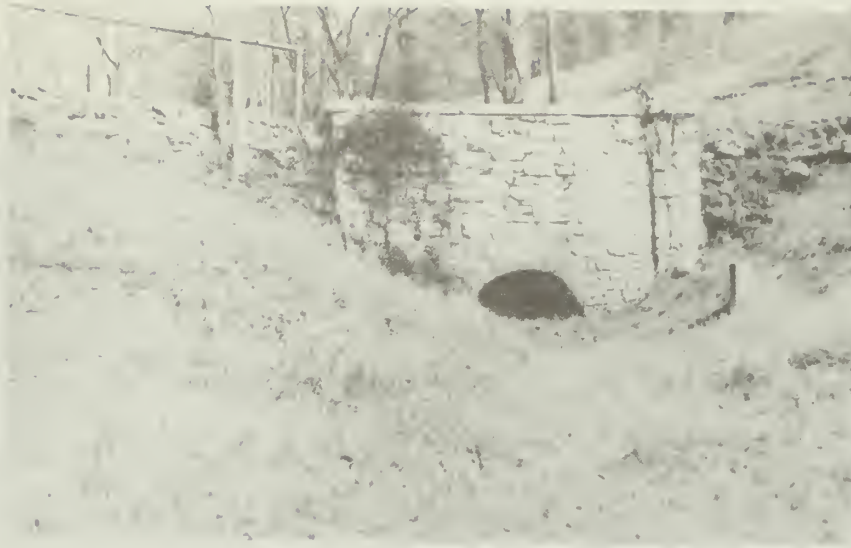
Figure 23. Stone Culvert on Hot Springs Mountain, date unknown  
(Source: Hot Springs National Park)

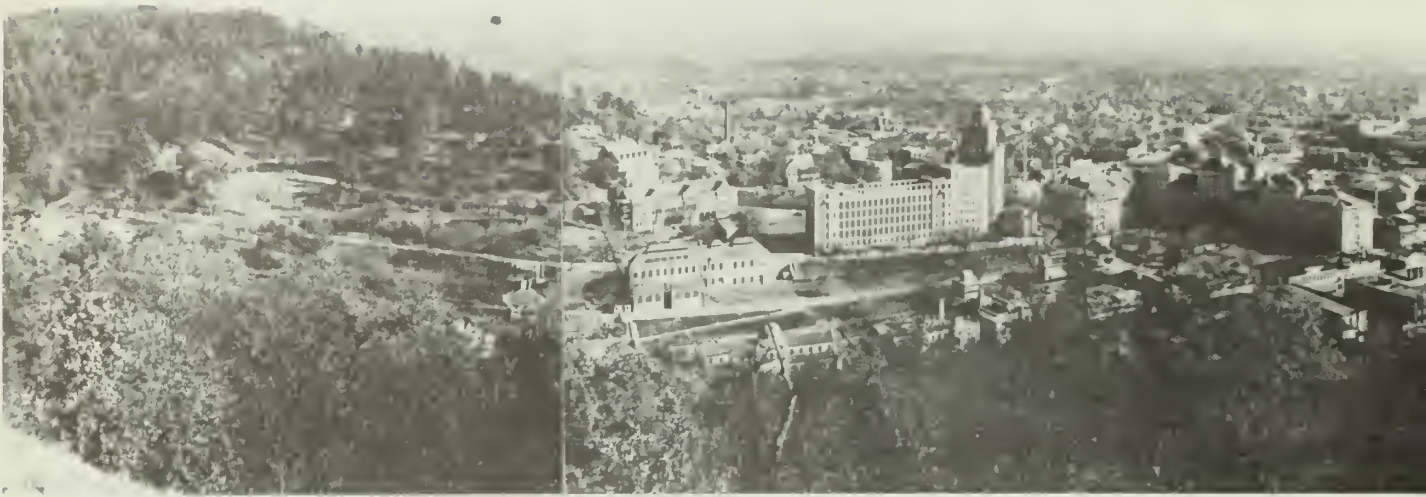
Figure 24. Bathhouse Row and Upper Terrace with Promenade Grading Completed, ca. 1937  
(Source: Hot Springs National Park)

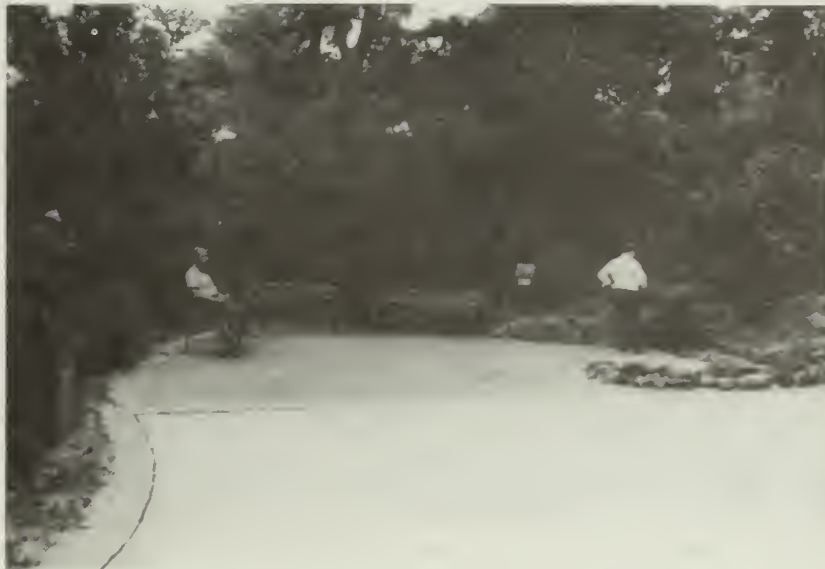
Dry-laid tufa-rock retaining walls

Seating area

Figure 39. Display Springs Subunit, Looking at Seating Area, 1984  
(Source: Hot Springs National Park)

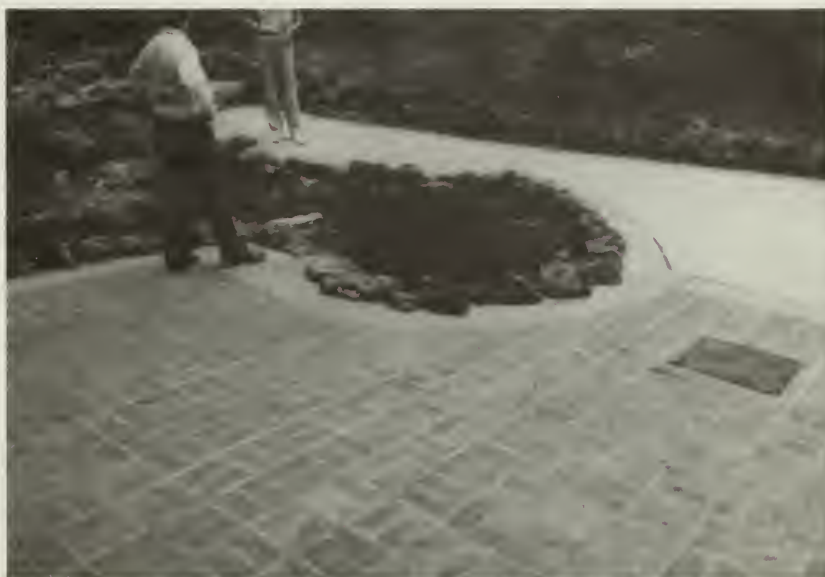
Figure 40. Display Springs Subunit, Looking at Display Pool, 1984  
(Source: Hot Springs National Park)

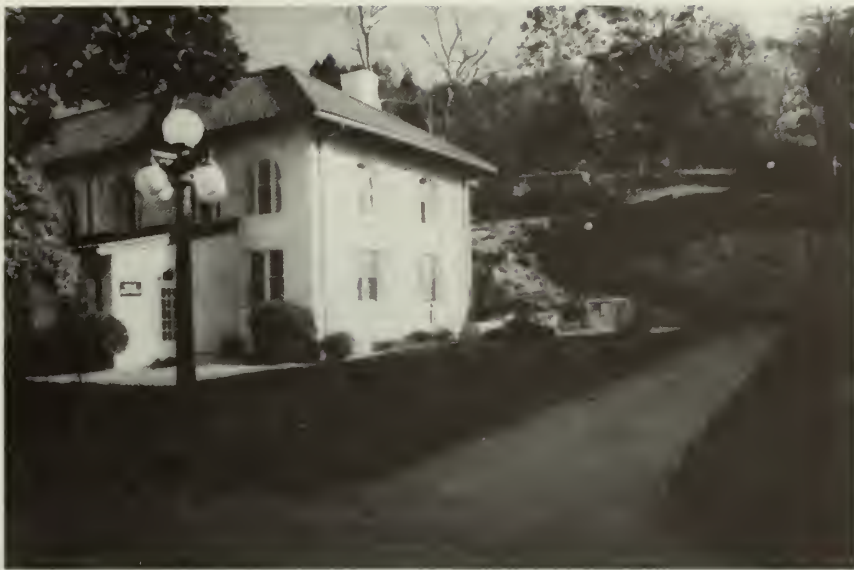
Figure 41. Maurice Display Springs Subunit, Looking from Magnolia Promenade, 1984  
(Source: Hot Springs National Park)

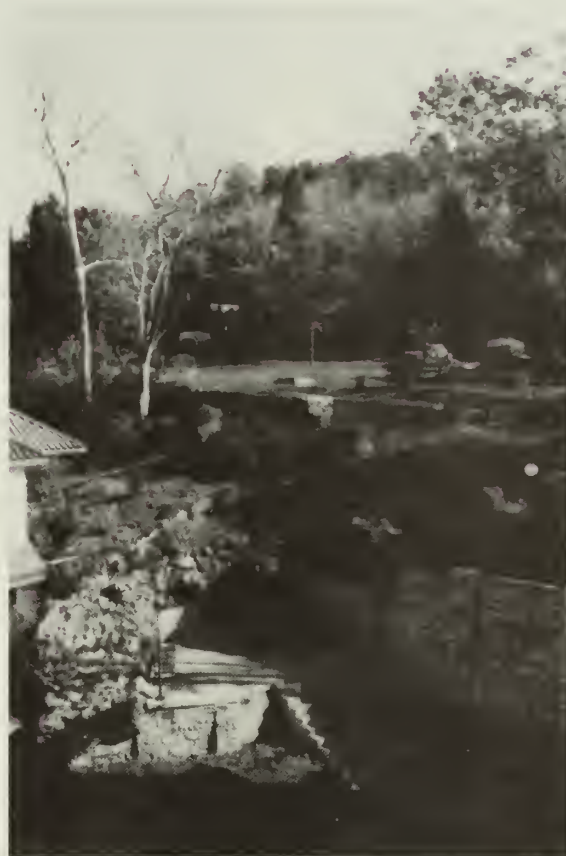
Figure 42. Maurice Display Springs Subunit, Looking Down from Maurice Bathhouse, 1984  
(Source: Hot Springs National Park)

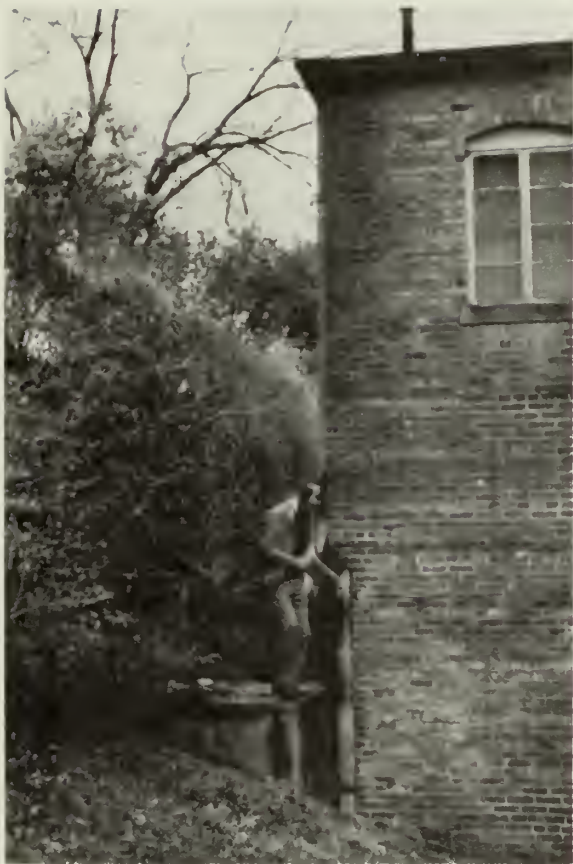
Figure 43. Transition Area Subunit, Area behind Buckstaff Bathhouse, 1984  
(Source: Hot Springs National Park)

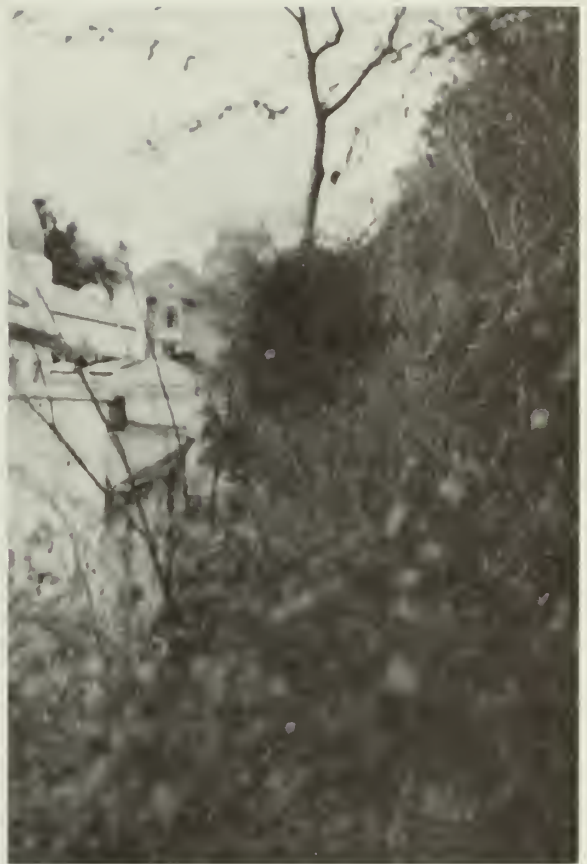
Figure 44. Transition Area Subunit, Area behind Ozark Bathhouse, 1984  
(Source: Hot Springs National Park)

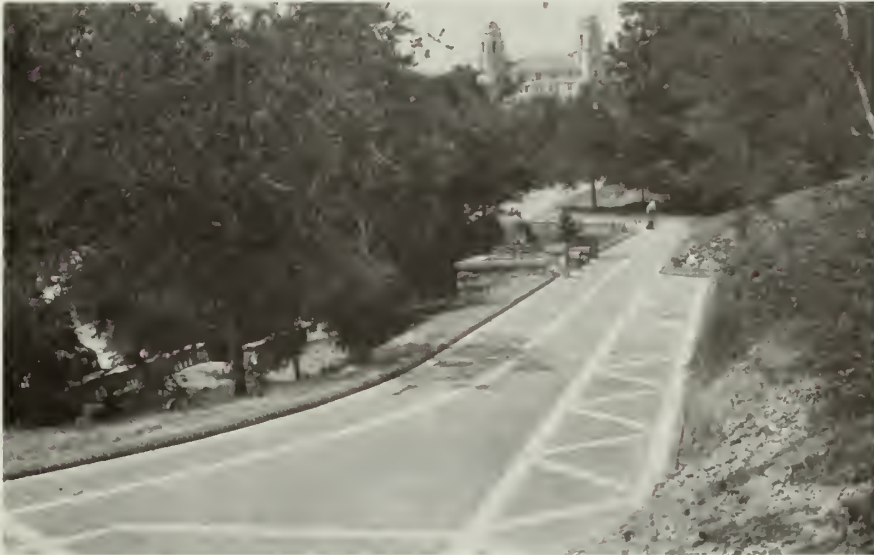
Figure 46. Grand Promenade Subunit, Looking North at Point where Main Entrance Ties into Promenade, date unknown  
(Source: Technical Information Center Photo Files, Denver Service Center, NPS, Denver)

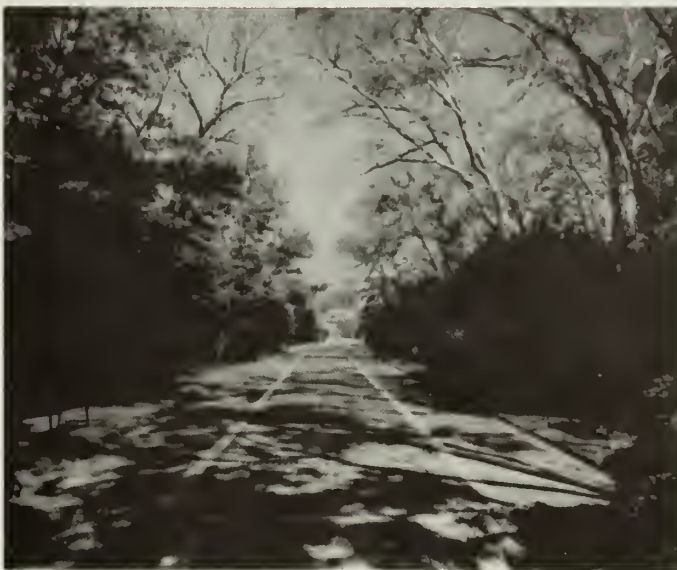
Figure 47. Grand Promenade Subunit, Looking North along Long Axis of Promenade, 1984  
(Source: Hot Springs National Park)

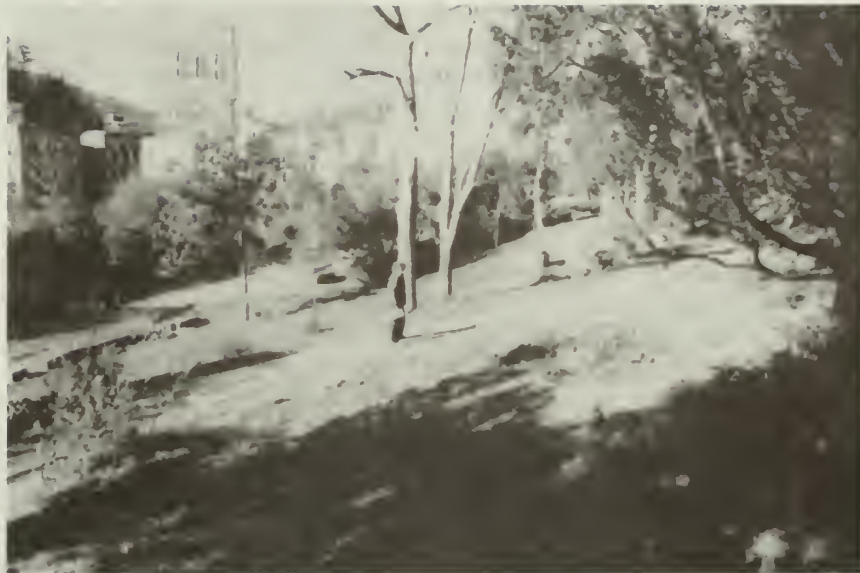
Figure 48. Open Lawn Bays Subunit, 1984 (Source: Hot Springs National Park)

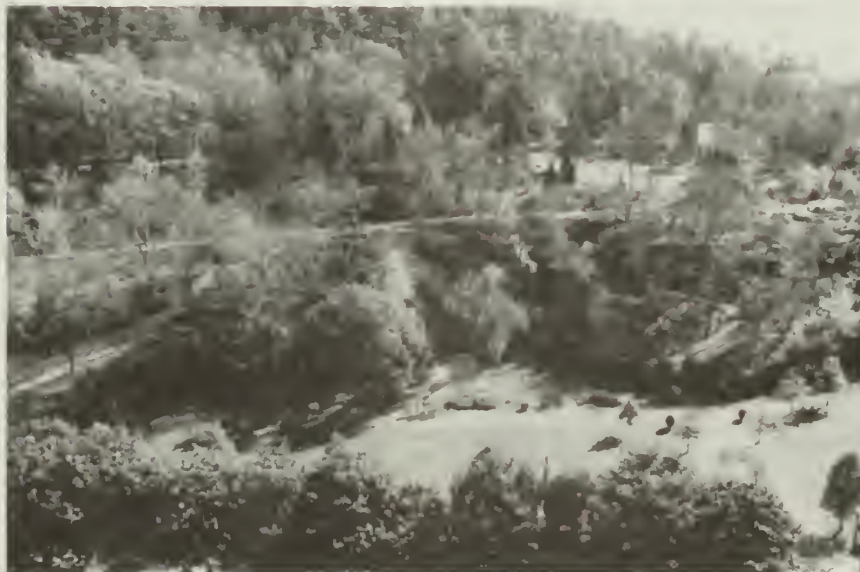
Figure 49. Open Lawn Bays Subunit, Looking across Arlington Lawn at Open Bays from Arlington Hotel, 1984 (Source: Hot Springs National Park)

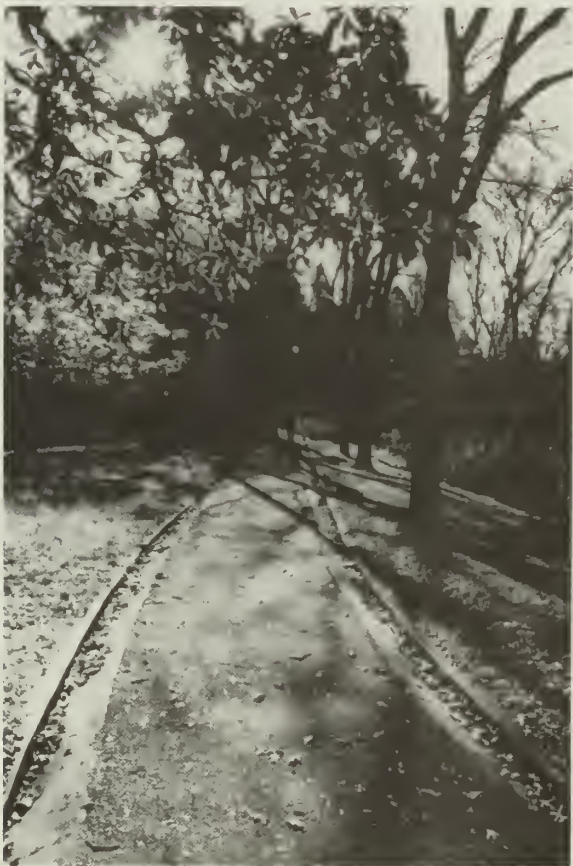
Figure 51. Open Woods Subunit, Looking Along Paved Trail, 1984 (Source: Hot Springs National Park)

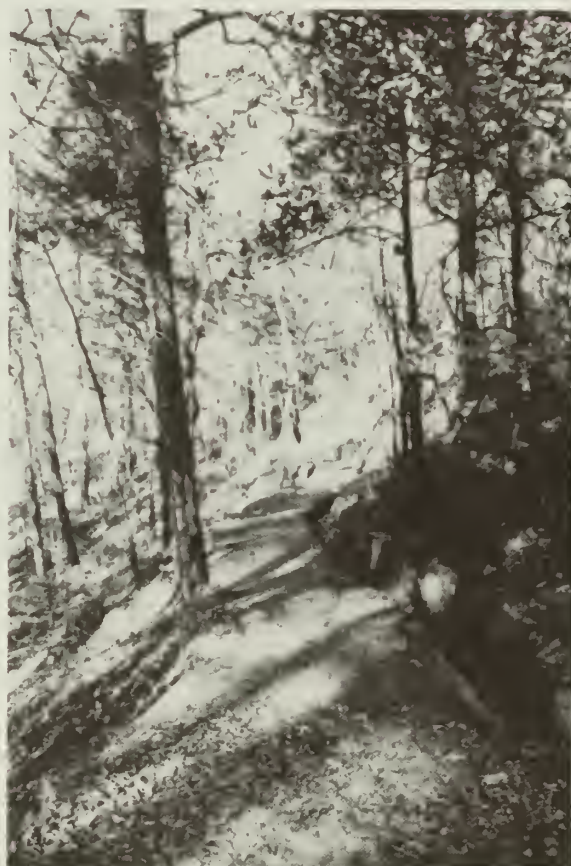
Figure 52. Open Woods Subunit, Looking Along Unpaved Trail, 1984 (Source: Hot Springs National Park)

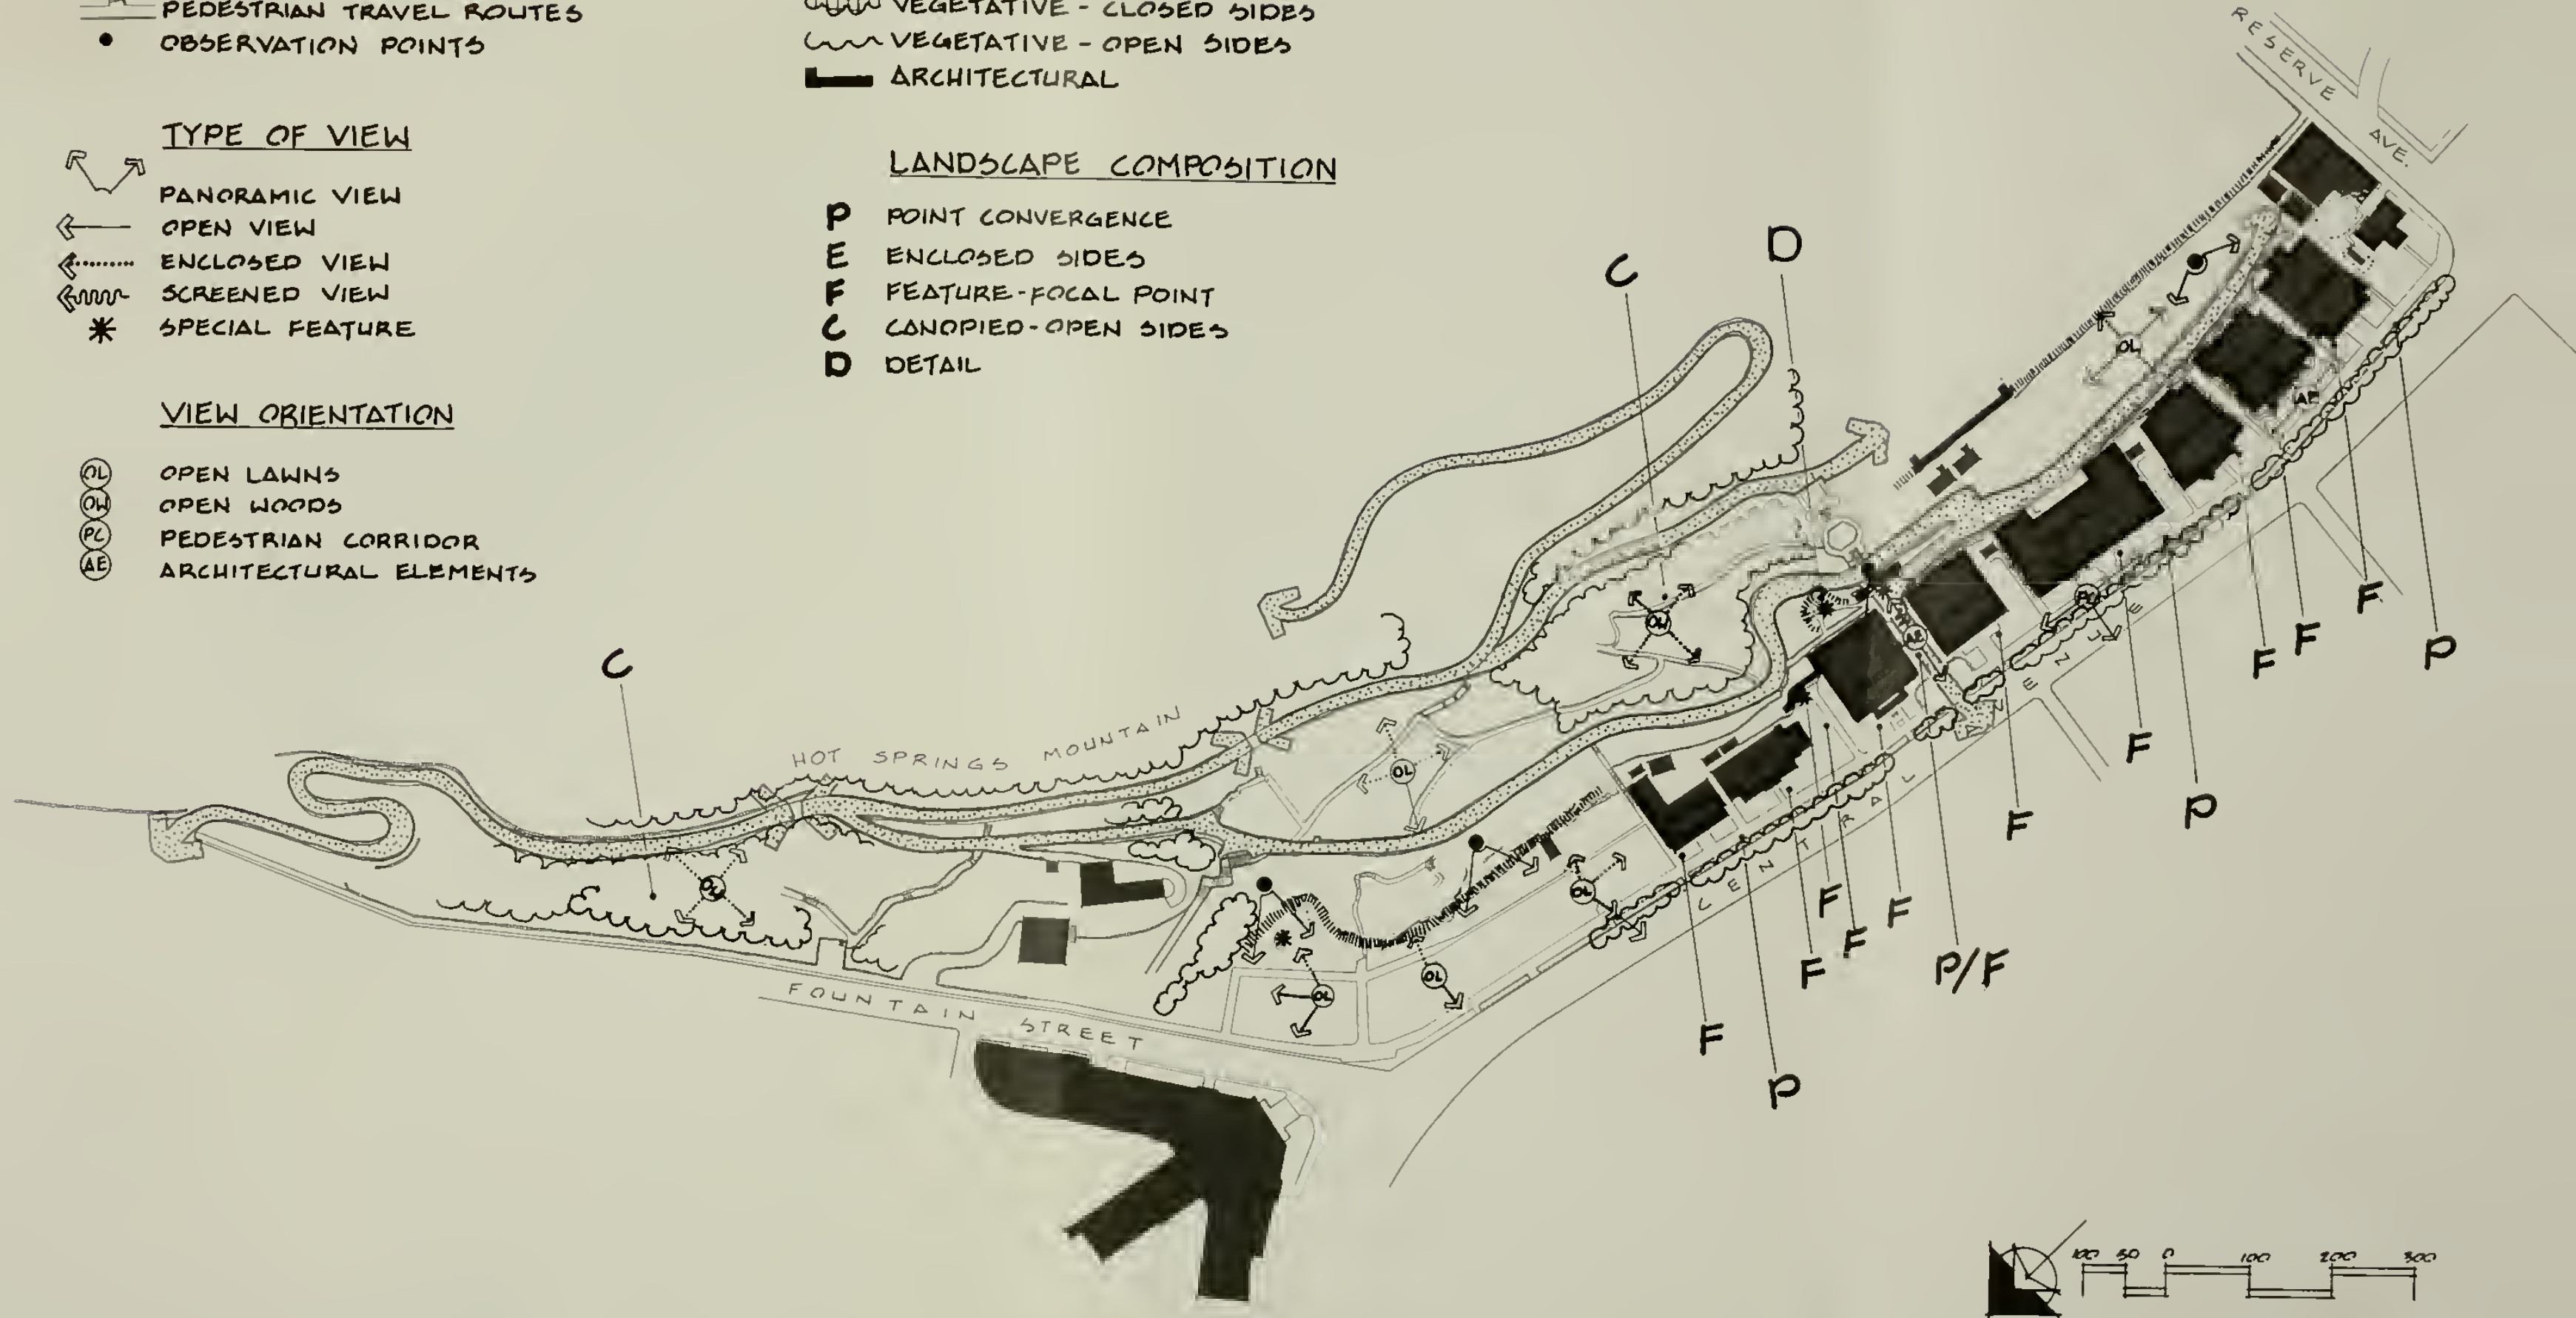
DESIGNED <b>G. JOHNSON</b>	SUB SHEET NO.	TITLE OF SHEET <b>SPATIAL ORGANIZATION &amp; FUNCTION ANALYSIS</b>	DRAWING NO. <b>128</b>
DRAWN <b>G. JOHNSON</b>			<b>25,007</b>
TECH. REVIEW			PKG. NO.
DATE <b>3/85</b>			SHEET <b>1</b>
			OF
